Bloodworth, Alan G. and Houlsby, Guy T.. (2016) Analysis of pre-vault tunnelling interaction with buildings. Proceedings of the Institution of Civil Engineers - Geotechnical Engineering.

Analysis of pre-vault tunnelling interaction with buildings

Abstract

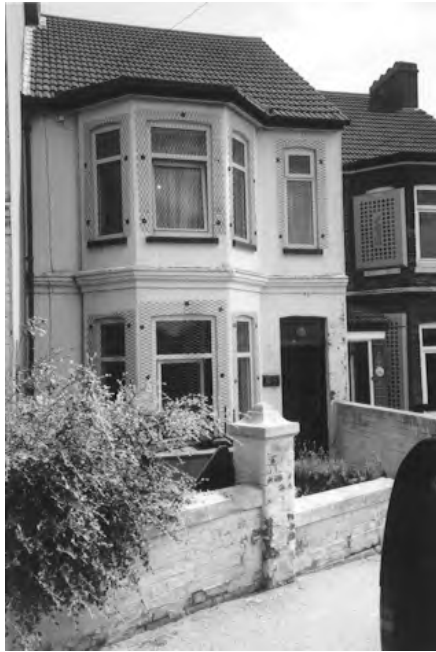
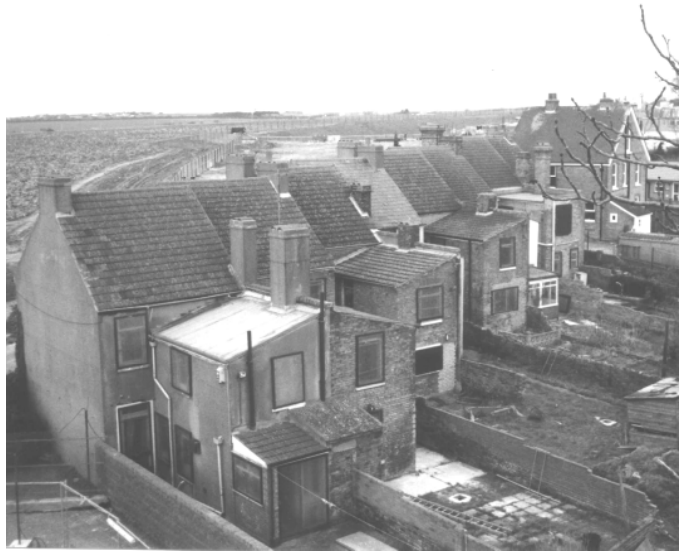
Figure 3: Views to the (a) front and (b) rear of terrace of cottages

The tunnel passed at 40° skew beneath a terrace of eight cottages (Fig. 2) with a cover of only 6m (approximately half a diameter). The cottages date from the early 1900's and are two-storey with no basements (Fig. 3). Each cottage has an extension wing at the back, and is staggered relative to the next by 2m. The structural form is load-bearing brick masonry (solid 220mm thick) on shallow strip foundations, with timber suspended floors and ceilings. Although some alterations have taken place, the main load bearing walls – front, rear and party walls – have been retained, along with the important openings to the front and rear.
